# MIRES ON THE MOORS

Science and Evidence Report 2020

# Mires On The Moors Project

## Science and Evidence Report 2020

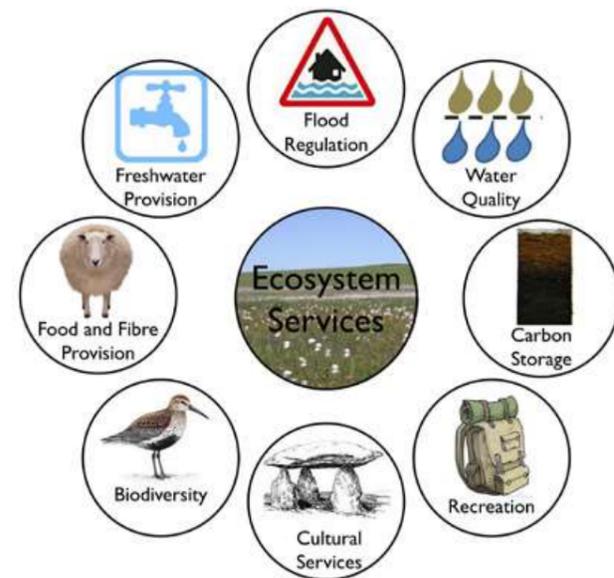
Ecosystem services provided by a functioning peatland.

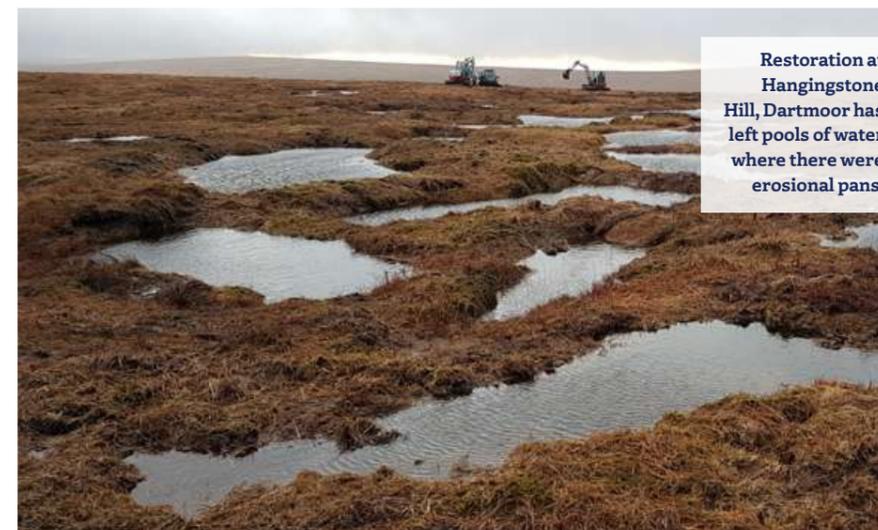
Restoration at Hangingstone Hill, Dartmoor has left pools of water where there were erosional pans.

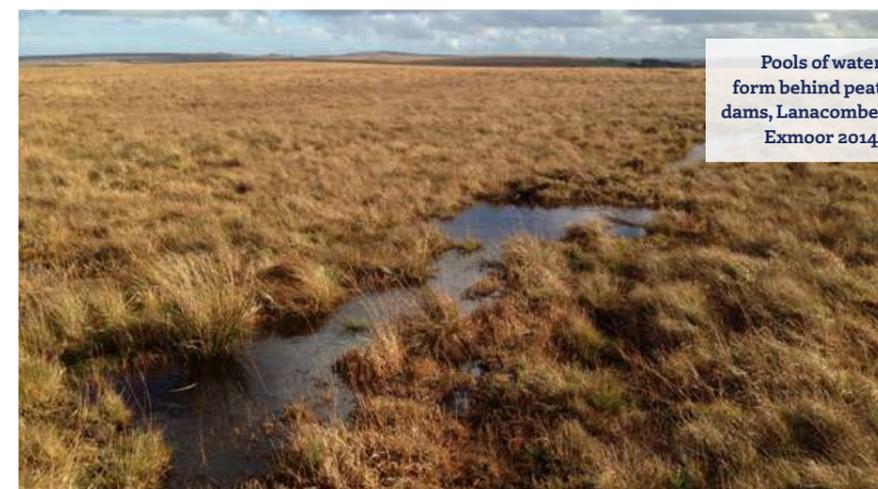
Pools of water form behind peat dams, Lanacombe, Exmoor 2014.

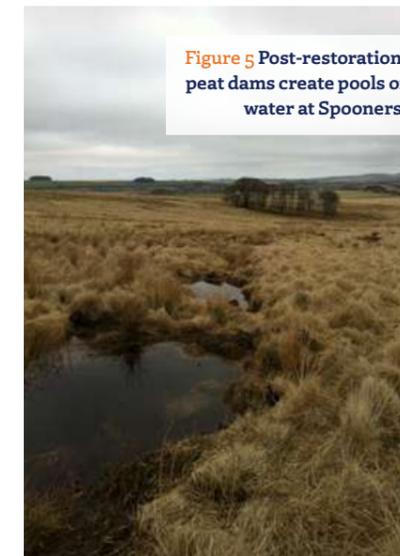
Figure 5 Post-restoration, peat dams create pools of water at Spooners.

Aclands and Spooners were restored, by ditch blocking with peat and wooden dams, in spring 2013 and 2014 respectively (Figure 5).

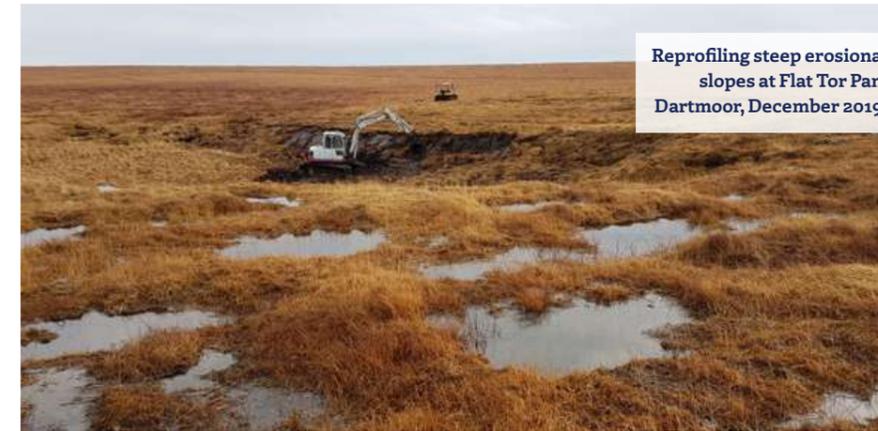
Reprofiling steep erosional slopes at Flat Tor Pan, Dartmoor, December 2019.

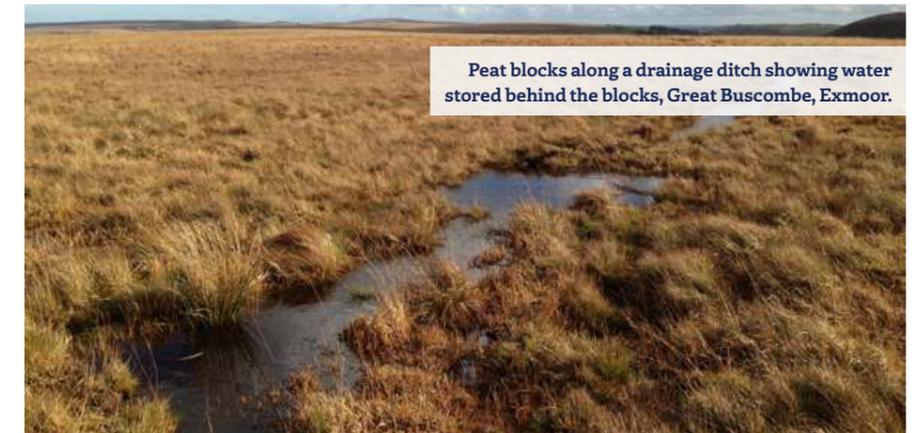
Peat blocks along a drainage ditch showing water stored behind the blocks, Great Buscombe, Exmoor.

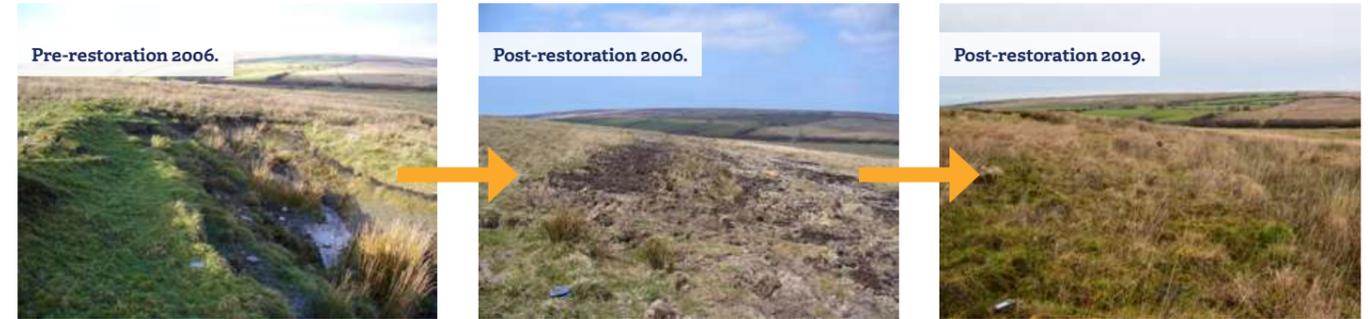
Figure 10 Fixed point photography from Roostichen, Exmoor; pre-restoration (2006), immediately post-restoration (2006) and 13 years post-restoration (2019).

Peatland restoration aims to bring about landscape change. In order to demonstrate and monitor landscape change associated with restoration fixed point photography is used (Figure 10). There are now over 60 pre- and post-restoration locations across Exmoor and Dartmoor.

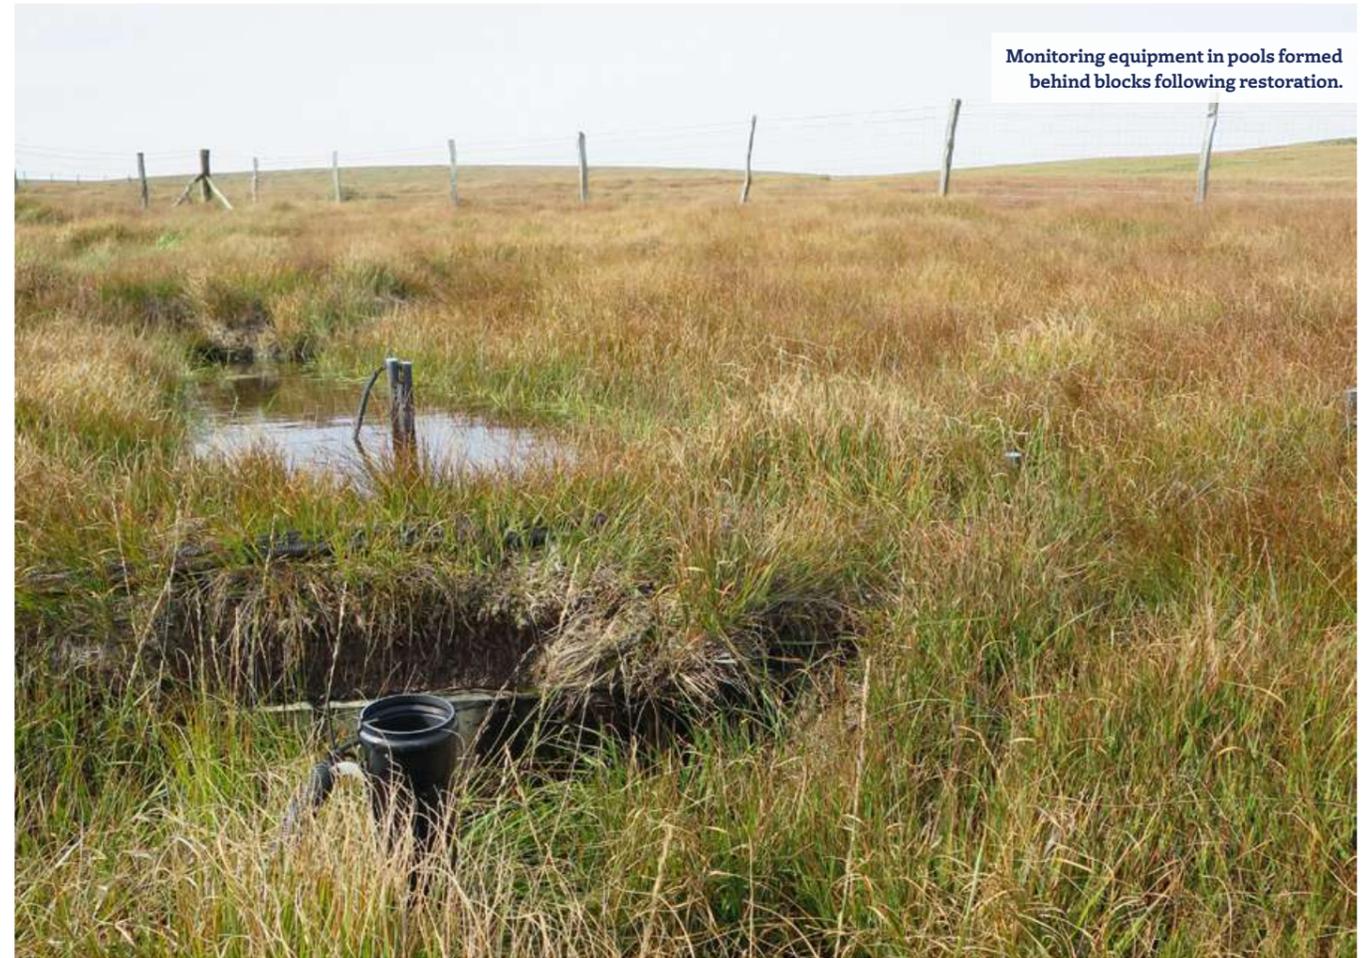
Monitoring equipment in pools formed behind blocks following restoration.

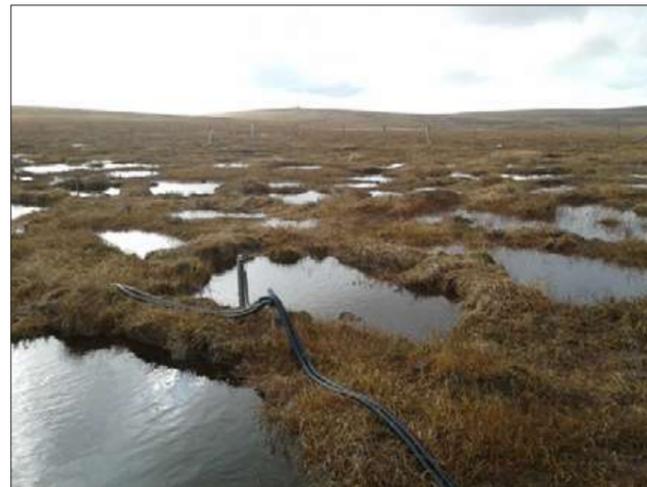
Figure 18 Photos and illustration of how restoration has altered the hydrological connectivity of the monitored dendritic landforms from pre-restoration (left) to immediately post-restoration (right).

Pre-restoration, gully runoff was characterised by flashy flows, an ephemerally dry gully and dendritic erosional "pan" features (Figure 18). Average water table depths pre-restoration were ca. 20 cm below the surface in vegetated areas, but fell to >40 cm below the soil surface during dry periods. The pan features rarely supported water tables above the surface; only during the wettest conditions (Figure 19). In the vegetated areas closest to the bare peat pans (0 to 1 m from the edge), water tables never rose to within ca. 5 cm of the surface (Figure 19) which would be considered normal in a healthy peat bog. Consequently, the areas of vegetated peat immediately surrounding the bare peat pans were permanently dry, causing peat collapse and the expansion of the dendritic pan/gully

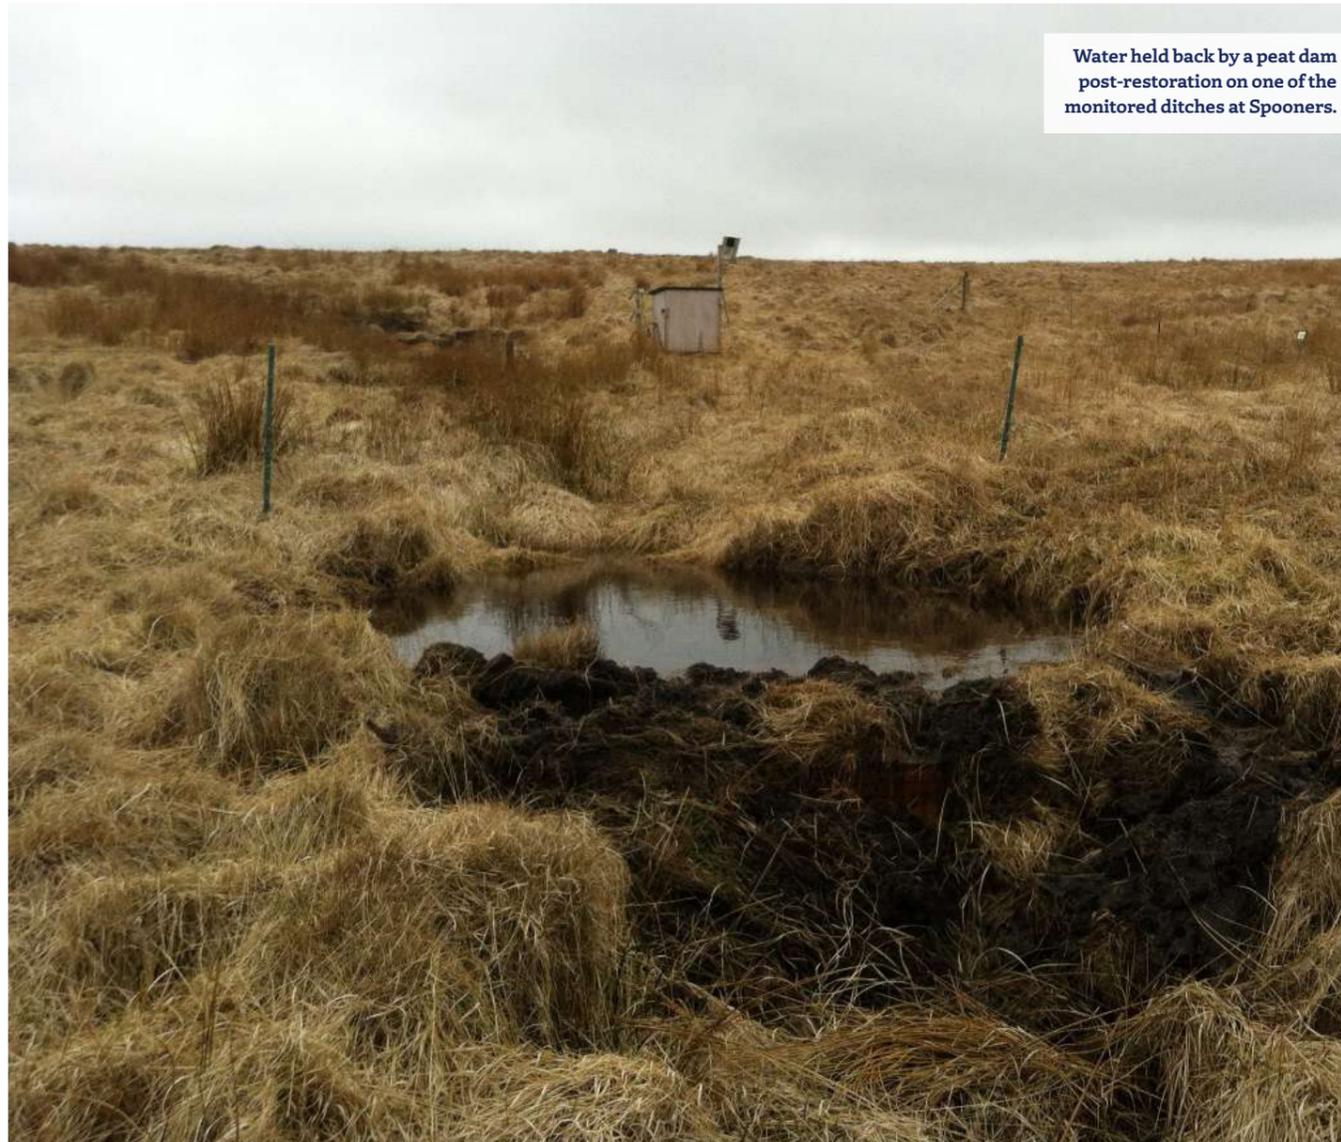
Water held back by a peat dam post-restoration on one of the monitored ditches at Spooners.

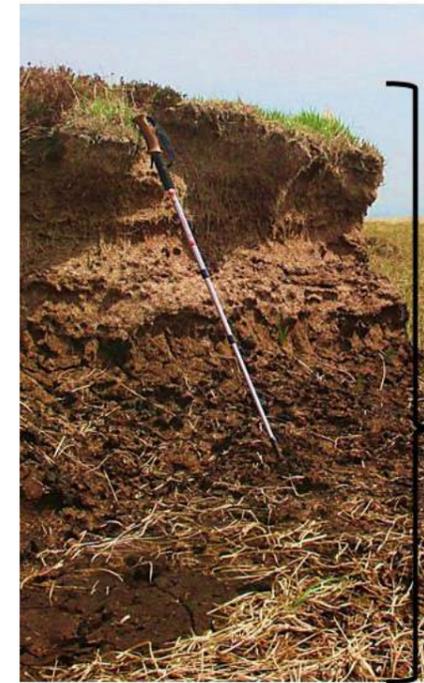
Post-restoration carbon source zone; newer, less discoloured carbon

Pre-restoration carbon source zone; includes older, more discoloured carbon

in Specific ultra-violet absorbance ( $Abs^{254}/DOC$ ) (Figure 25 middle) suggesting a shift towards carbon from fresh plant litter, as opposed to release of deeper and older carbon within the peat soil (Figure 27).

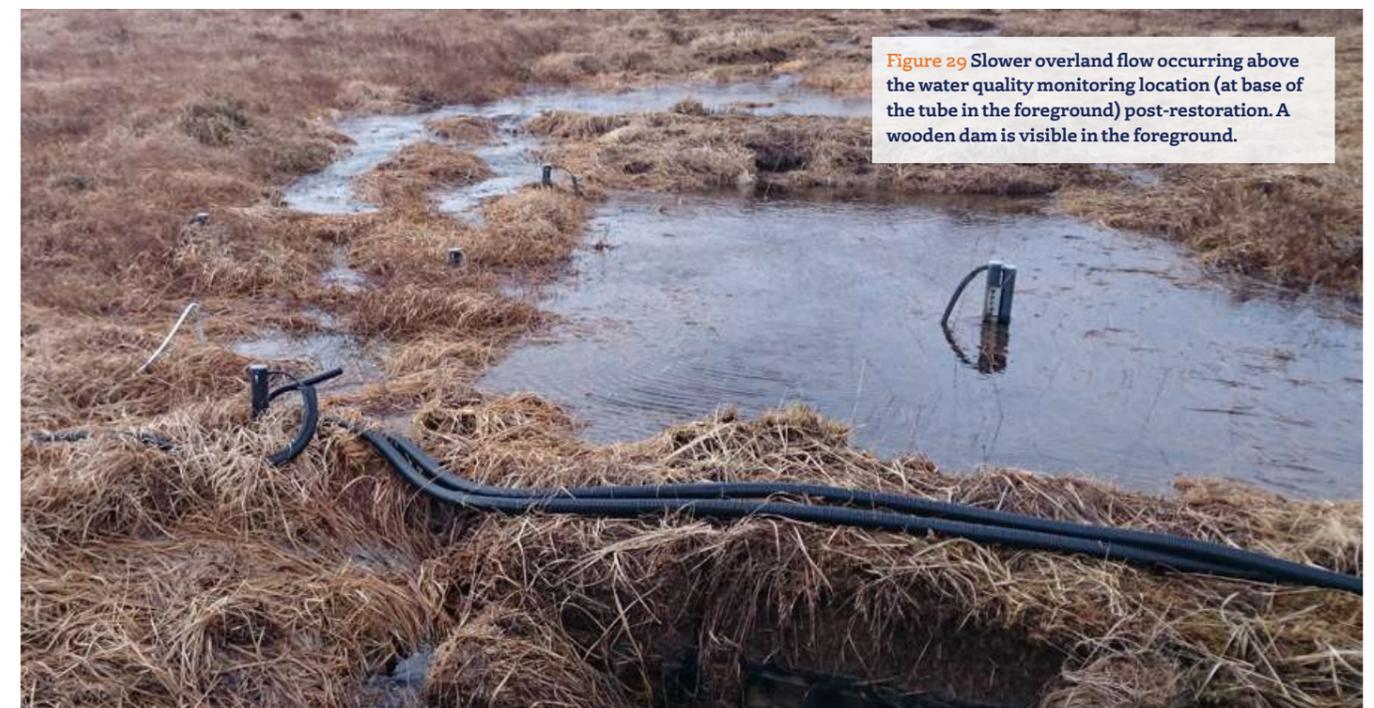
**Figure 29** Slower overland flow occurring above the water quality monitoring location (at base of the tube in the foreground) post-restoration. A wooden dam is visible in the foreground.

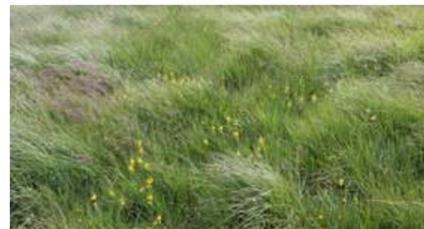
**Figure 33** A cluster of bog asphodel (*Narthecium ossifragum*) flowers on Aclands July 2017.

Bog asphodel (*Narthecium ossifragum*) is a common component of blanket bog vegetation, seen as patches of bright green fleshy leaves growing from patches of rhizomes (underground stems), with conspicuous yellow flowers in early summer<sup>1</sup> (Figure 33). The leaves and especially the flowers are readily eaten by grazing livestock but contain toxins that can cause acute photosensitization and fatal liver and kidney disease in lambs and calves<sup>2,3</sup>. This research aimed to address concerns that restoration would increase the occurrence of bog asphodel and consequently livestock fatalities.

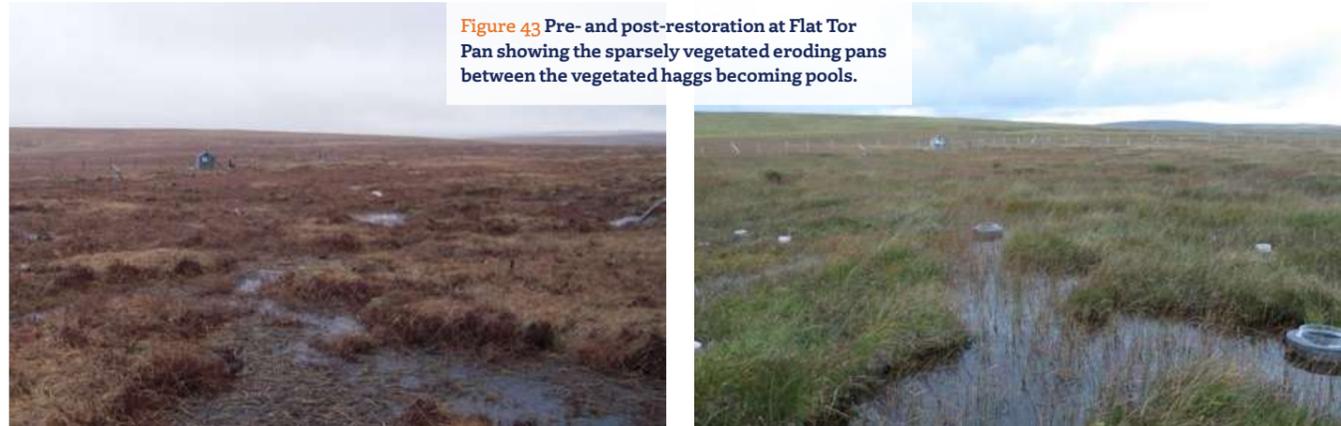
Figure 43 Pre- and post-restoration at Flat Tor Pan showing the sparsely vegetated eroding pans between the vegetated hagsgs becoming pools.

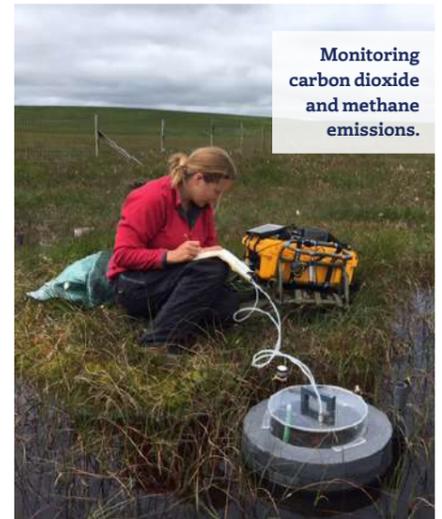
Monitoring carbon dioxide and methane emissions.
